“SHOCK STOP” TO THE RESCUE

PREVENTS CABLE DAMAGE ON “OVER-POWERED” BALANCERS

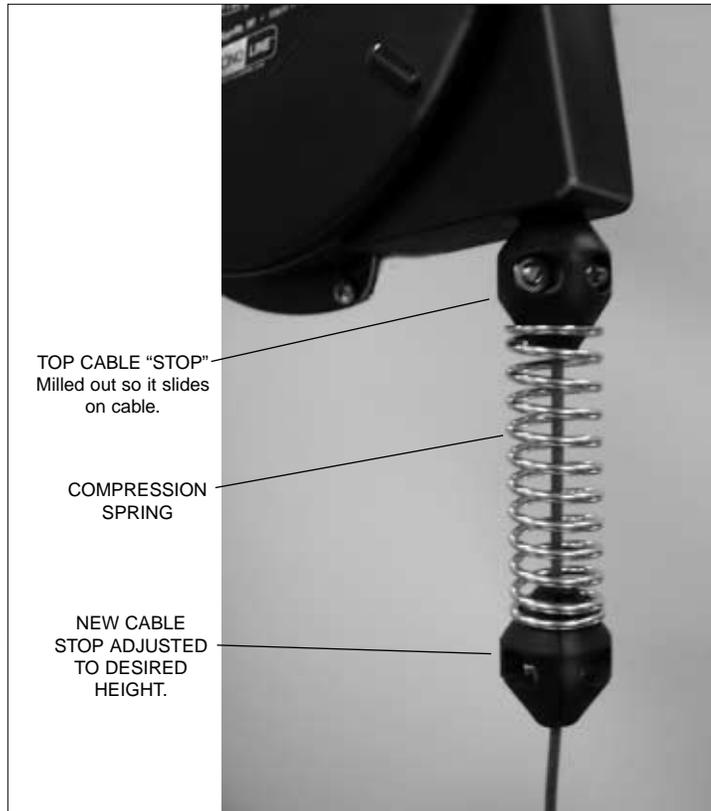
Cable breakage on tool balancers is extremely rare because of the tough, extremely durable nylon coated steel aircraft cable used. On most failure reports we receive, the cable breaks at the eye or, more precisely, just above the clip that is swaged around the cable to form the eye. Two of the primary causes of cable failure on Series BG balance reels are better classified as user error...(1) overtensioning the spring, and (2) allowing the tool to “slam” back into the balancer from a fully extended or near fully extended position. In most reported cases, both of these conditions are present.

The result of this “overtensioned slamming” is that the cable stop is slowly pushed down the cable until it is against the eye and can go no farther. Then, every time the tool is returned to the raised position the cable stop hits against the reel housing but the tool tries to keep moving, causing the cable to bend at the point between the stop and the eye. Bend any cable in the same place enough times and it will fatigue and break.

Now there is a mechanical means of minimizing this type of cable damage. We call it the “Shock Stop”. It consists of a new fixed stop, a compression spring and a second cable stop which has been milled out so it can't grip the cable and thus slides easily. The kit is easily installed by removing the existing stop, threading the eye through the spring, and installing the two new stops with the “slider” on top.
